Stage 1 Road Safety Audit.  
Church Street Junction Improvements,  
Athlone.

Job No. ST17466

Date 07 November 2016

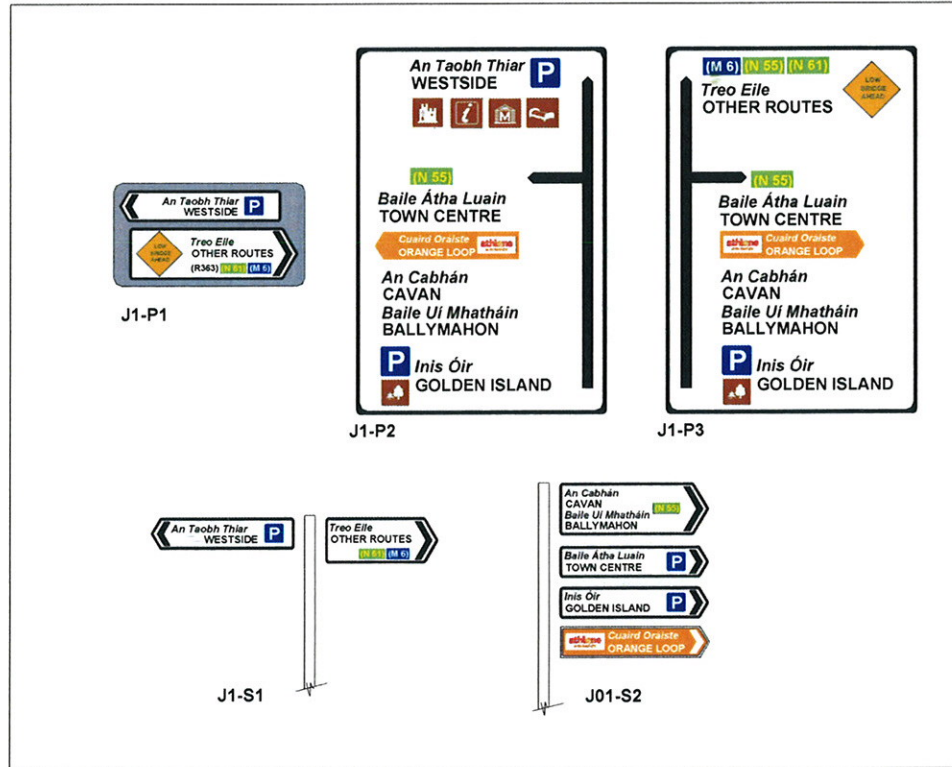
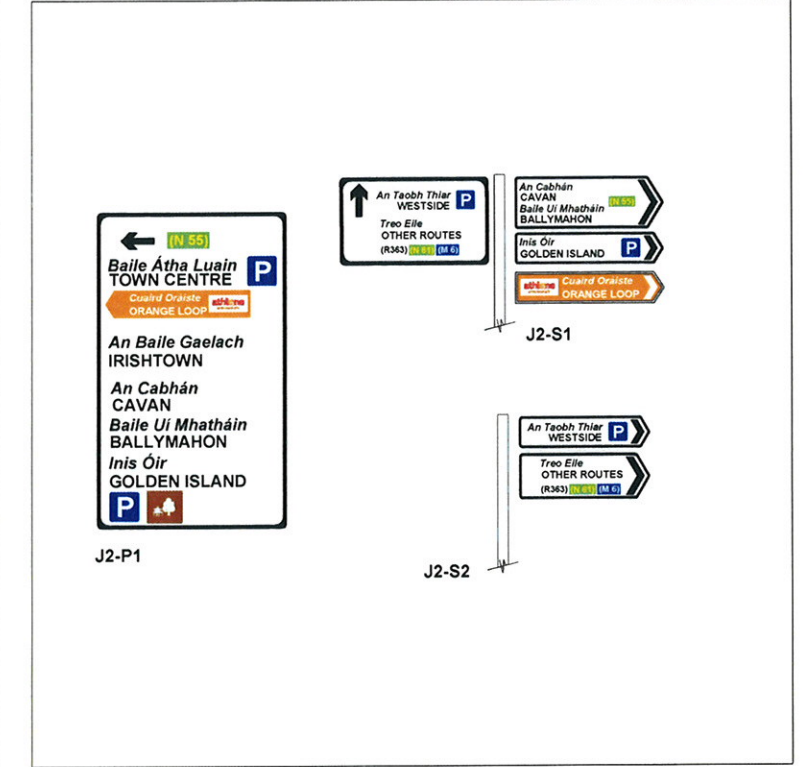
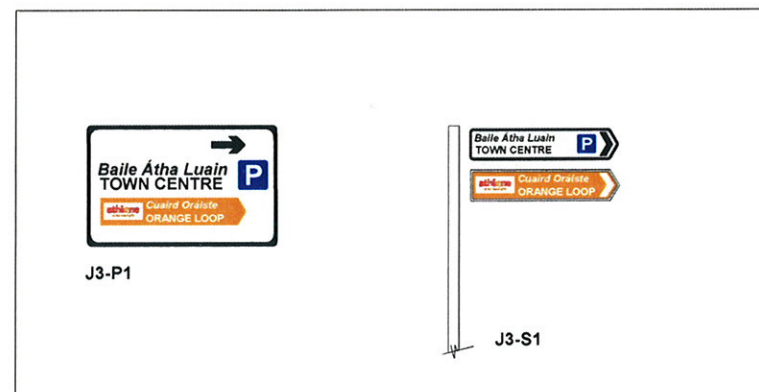
The proposed locations of all the above signs have problems will lack of space to provide the sign and also problems with the visibility to the signage. A lack of space for the signage will increase the risk of the signage being struck by a high sided vehicle. A lack of visibility to the sign will increase the risk of drivers missing the information on the sign and undertaking late sudden movements at the junction increasing the risk of causing a collision at the junction.

It is recommended that the locations of all the signage is reviewed to ensure the proposed locations are adequate in terms of space for the sign to be provided and also adequate forward visibility is provided to the sign to allow approaching drivers the time to take in the signs message.

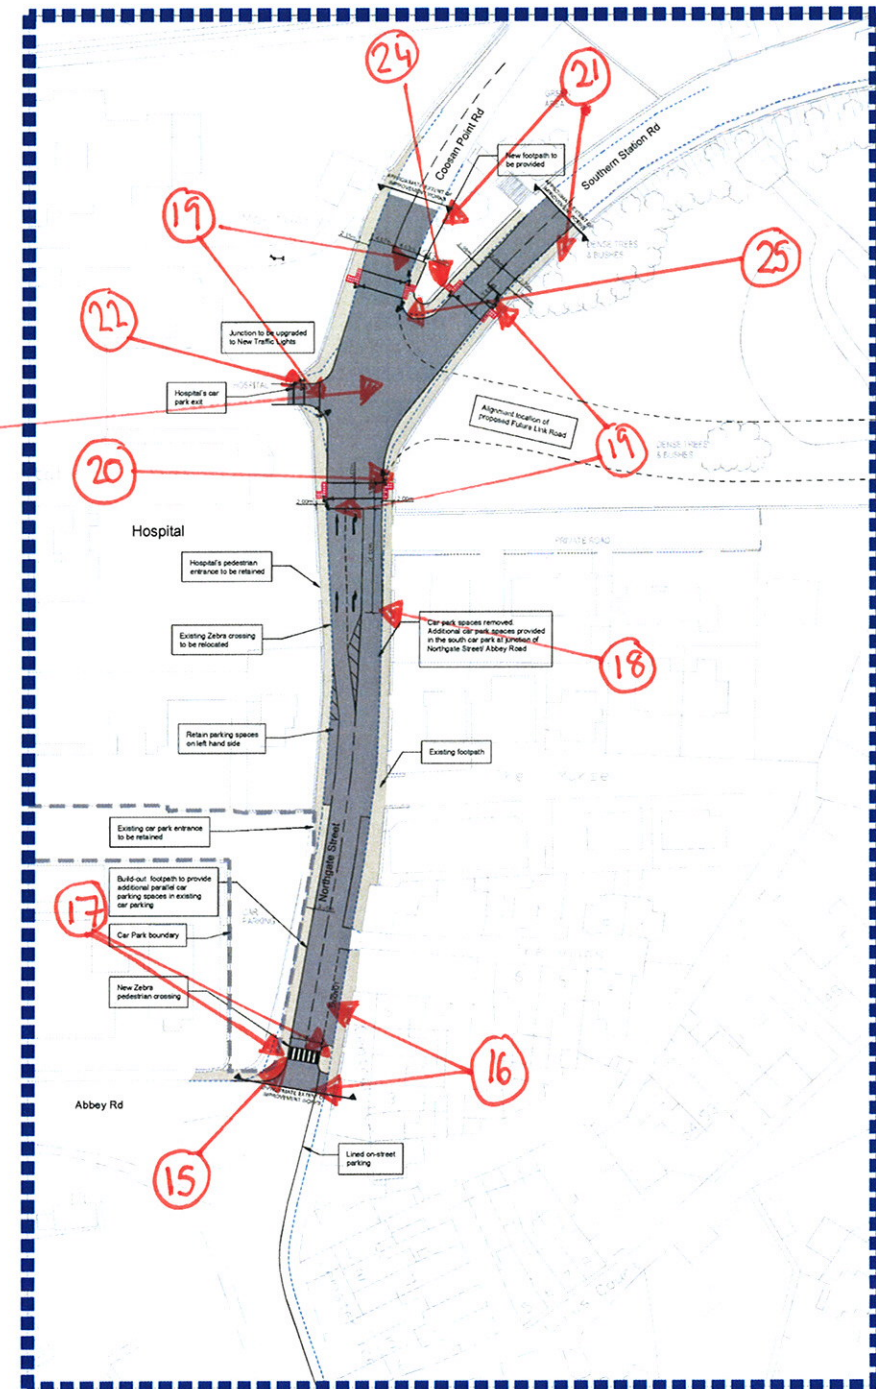
COOSAN POINT Rd / NORTHGATE STREET / SOUTHERN STATION Rd JUNCTION

- 3.24 **Problem:**  
Location: 24 – Footway connection between Coosan Point Road and Southern Station Road.
- Summary: Steep gradient on footway will increase the risk of pedestrians slipping in icy or wet conditions.

- The existing level difference between Coosan Point Road and Southern Station Road is significant and if a footway is provided around this side of the junction it is likely to be steeper than the recommended maximum gradient of 1 in 12. Footway steeper than 1 in 12 will be difficult and/or impossible for mobility impaired pedestrians to use and will increase the risks to them and also increase the risk of pedestrians slipping in wet or icy conditions.

- Recommendation:
- It is recommended that the footway link between Coosan Point Road and Southern Station Road is not steeper than 1 in 12 and preferably no steeper than 1 in 20. An alternative alignment of the footway using the grass verge area to the north of the junction to provide a ramped arrangement to achieve these gradients for mobility impaired pedestrians could be provided.

It is recommended that the swept path of all large vehicles that are anticipated to be undertaking this movement to be checked to ensure that they do not over run the footway or the stop line and if necessary the stop line on Southern Station Road and Coosan Point Road be set back to allow the movement to be undertaken safely.

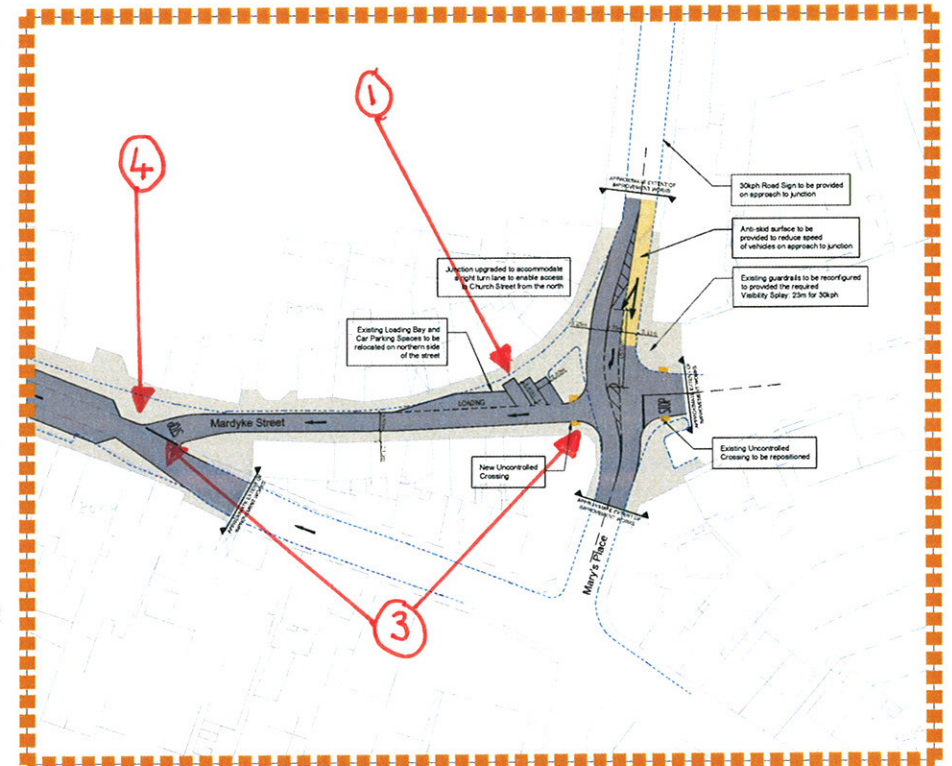
MARDYKE STREET / PUMP LANE / ST. MARY'S PLACE JUNCTION

Location: 1 – Angled parking bays on Mardyke Street

Summary: Risk of pedestrians using the crossing being struck by a vehicle reversing out of the parking bays.

Due to the angle of the three parking bays provided at the eastern end of Mardyke Street, vehicles will be encouraged to pull forwards into the parking bays and then reverse out of them when leaving. Due to the close proximity of the parking bays to the uncontrolled crossing reversing vehicles will have to cross the pedestrian crossing and this will increase the risk of a vehicle striking a pedestrian on the crossing.

Location: 2 – Signage J3-P1 on Mary's Place.

Summary: Narrow footway, insufficient space to provide signage and maintain clearance to the carriageway, increased risk of signage being struck by large vehicles.

At the proposed location of the sign the footway is narrow and buildings abut the back of the footway preventing the signage being moved away from the carriageway. Due to the size of the proposed signage it does not look possible to provide the signage in the location shown without overhanging the carriageway increasing the risk of the signage being struck by a large vehicle. The size of the sign would also require two posts, which will also block the narrow footway which may force pedestrians to step into the carriageway to avoid the sign posts and increasing the risk of being struck by a vehicle.

Location: 3 – Eastern and western end of Mardyke Street.

Summary: Narrow entrance and exit, risk of large vehicles over running footways and striking a pedestrian.

The proposals narrow the existing carriageway at both ends of Mardyke Street and the radii at the junctions are also reduced. Large service and / or refuse vehicles may have difficulty in entering and leaving Mardyke Street without over running the footways increasing the risk of striking a pedestrian.

It is recommended that either: a) the parking bays are angled in the opposite direction, so vehicles will drive past the parking bays before reversing into them, allowing them to drive out of them in a forward gear so vehicles do not need to reverse over the pedestrian crossing area; or b) the angled parking bays be removed and replaced with two parallel parking bays on Mary's Place and one parallel parking bay on Mardyke Street, which again will remove the need for any vehicles to reverse over the pedestrian crossing area.

It is recommended that the location of the signage is moved further northwards on Mary's Place to the end of the building line where additional space is available to provide the signage whilst maintaining sufficient lateral clearance to the edge of the carriageway. The sign posts should also be positioned so they do not obstruct the footway.

It is recommended that the swept path of all large vehicles that need to enter and leave Mardyke Street is checked to ensure they can undertake the turning movements at both ends without over running the footways.

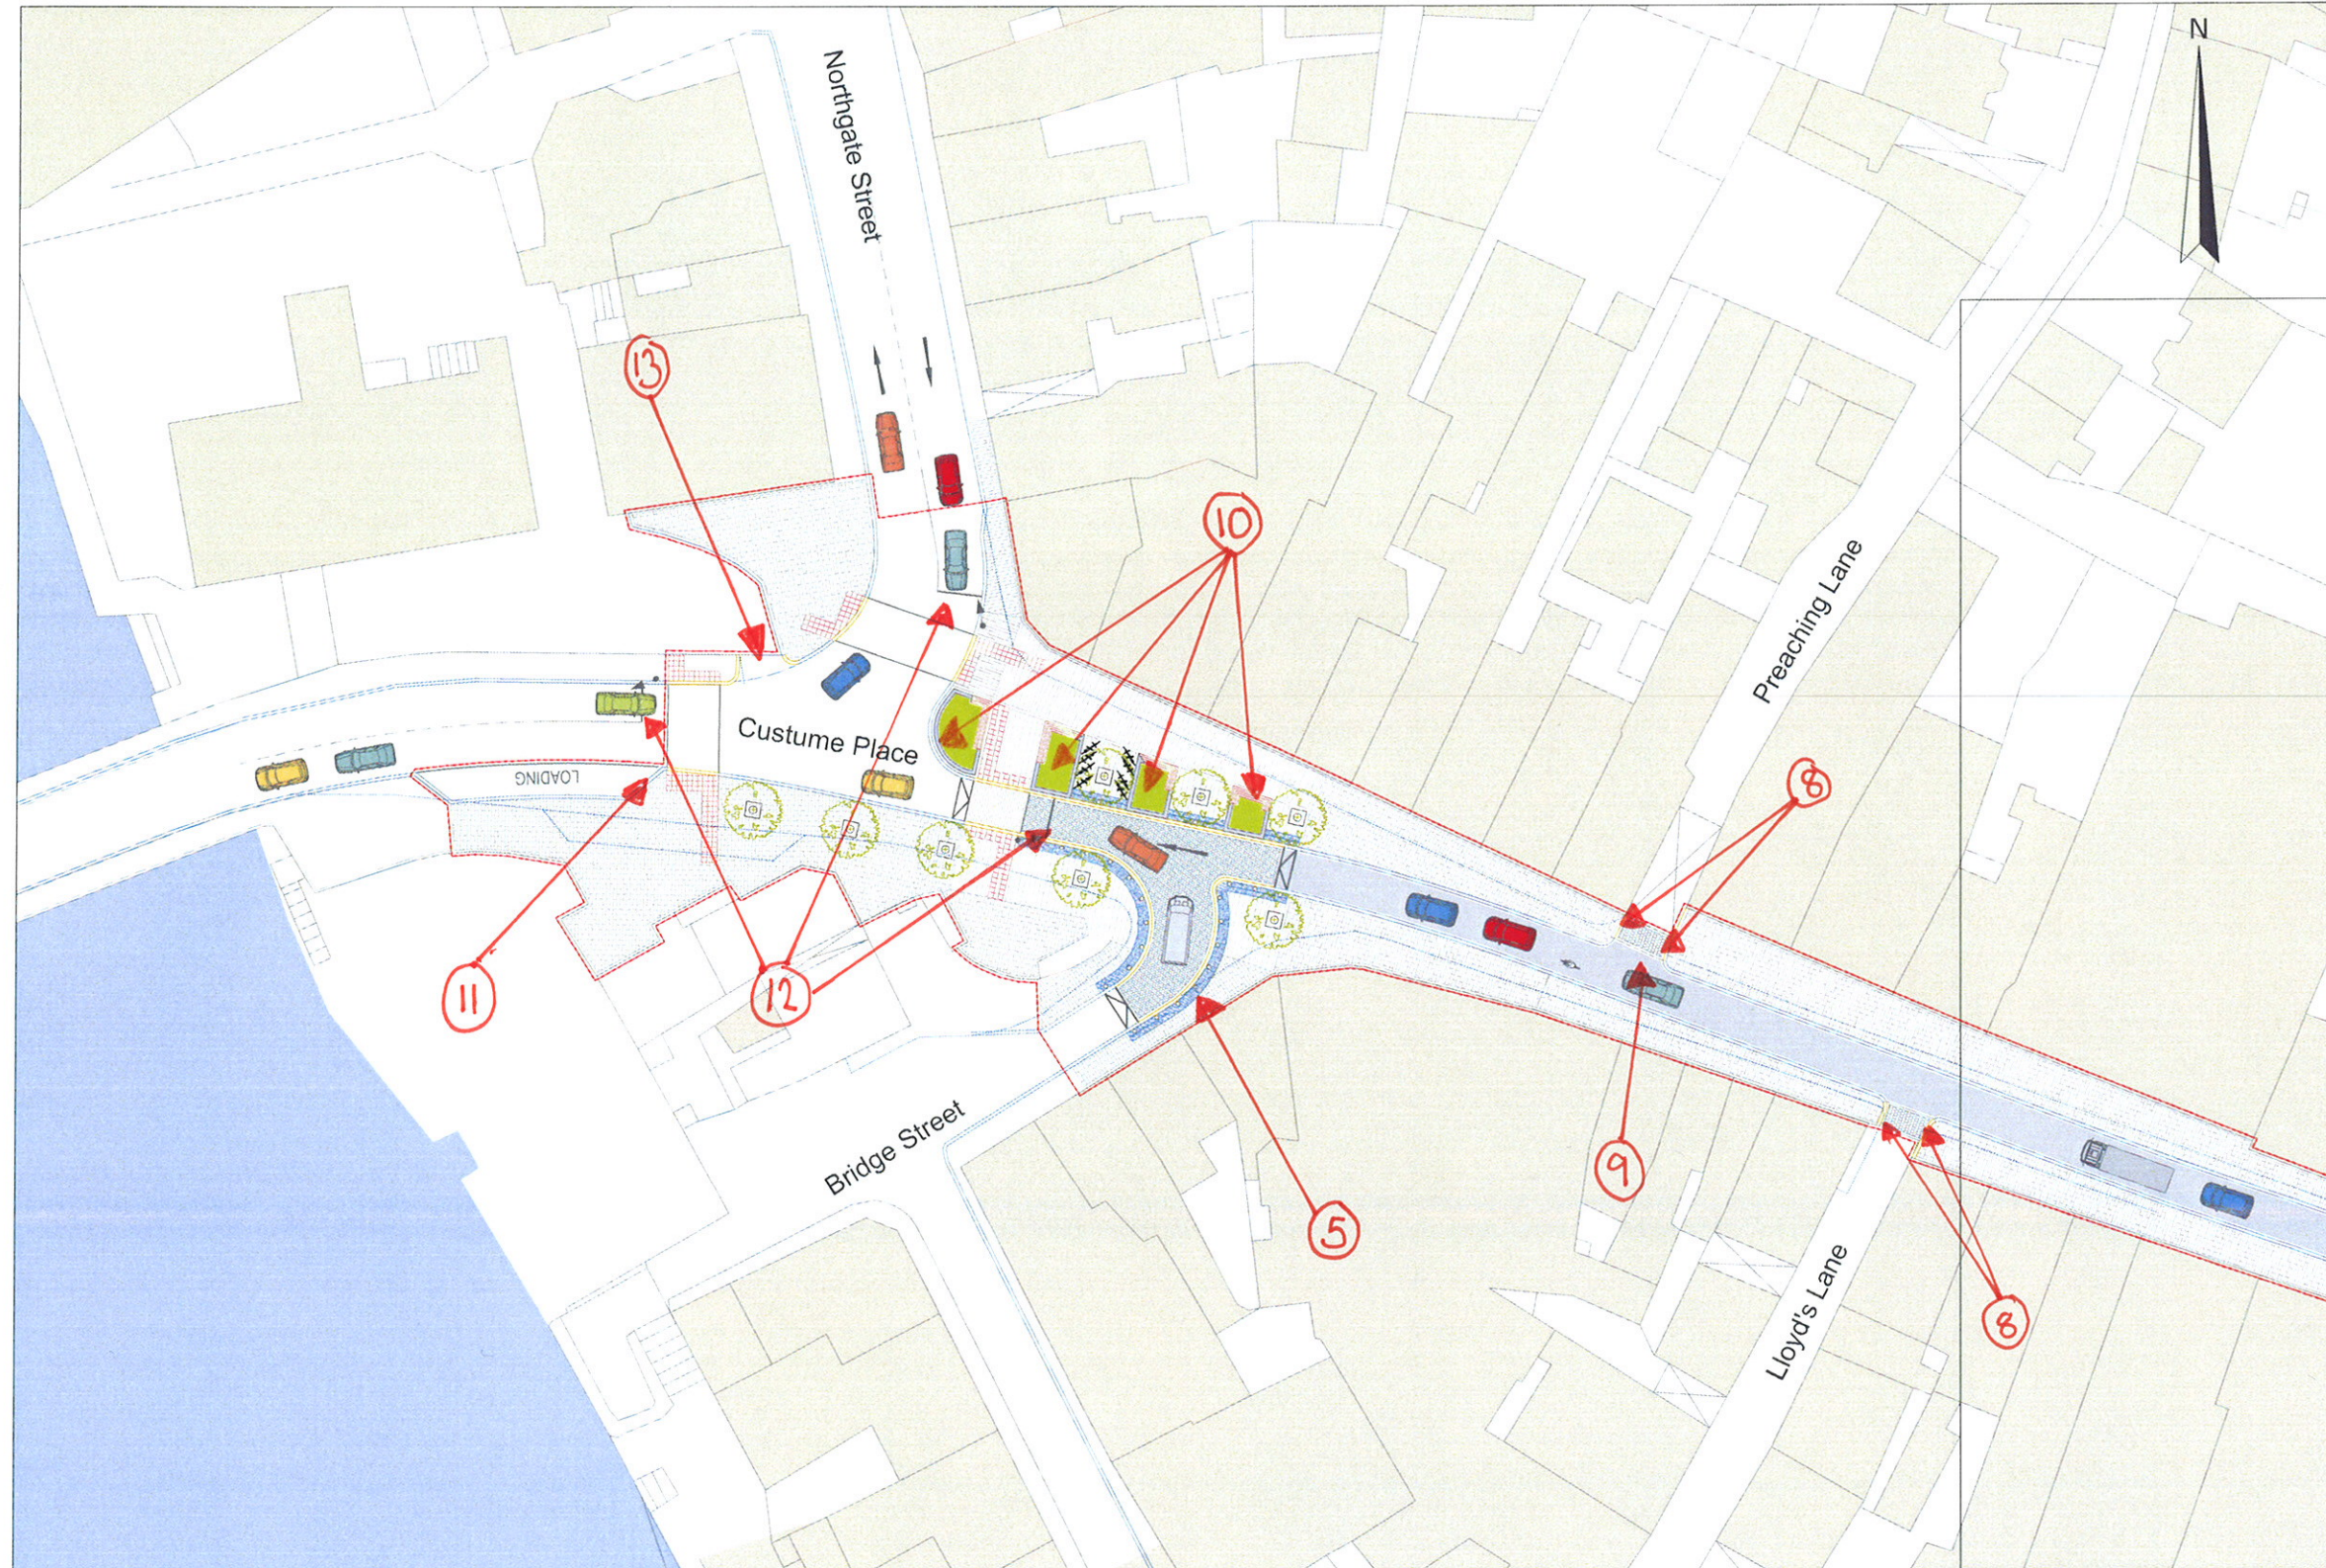
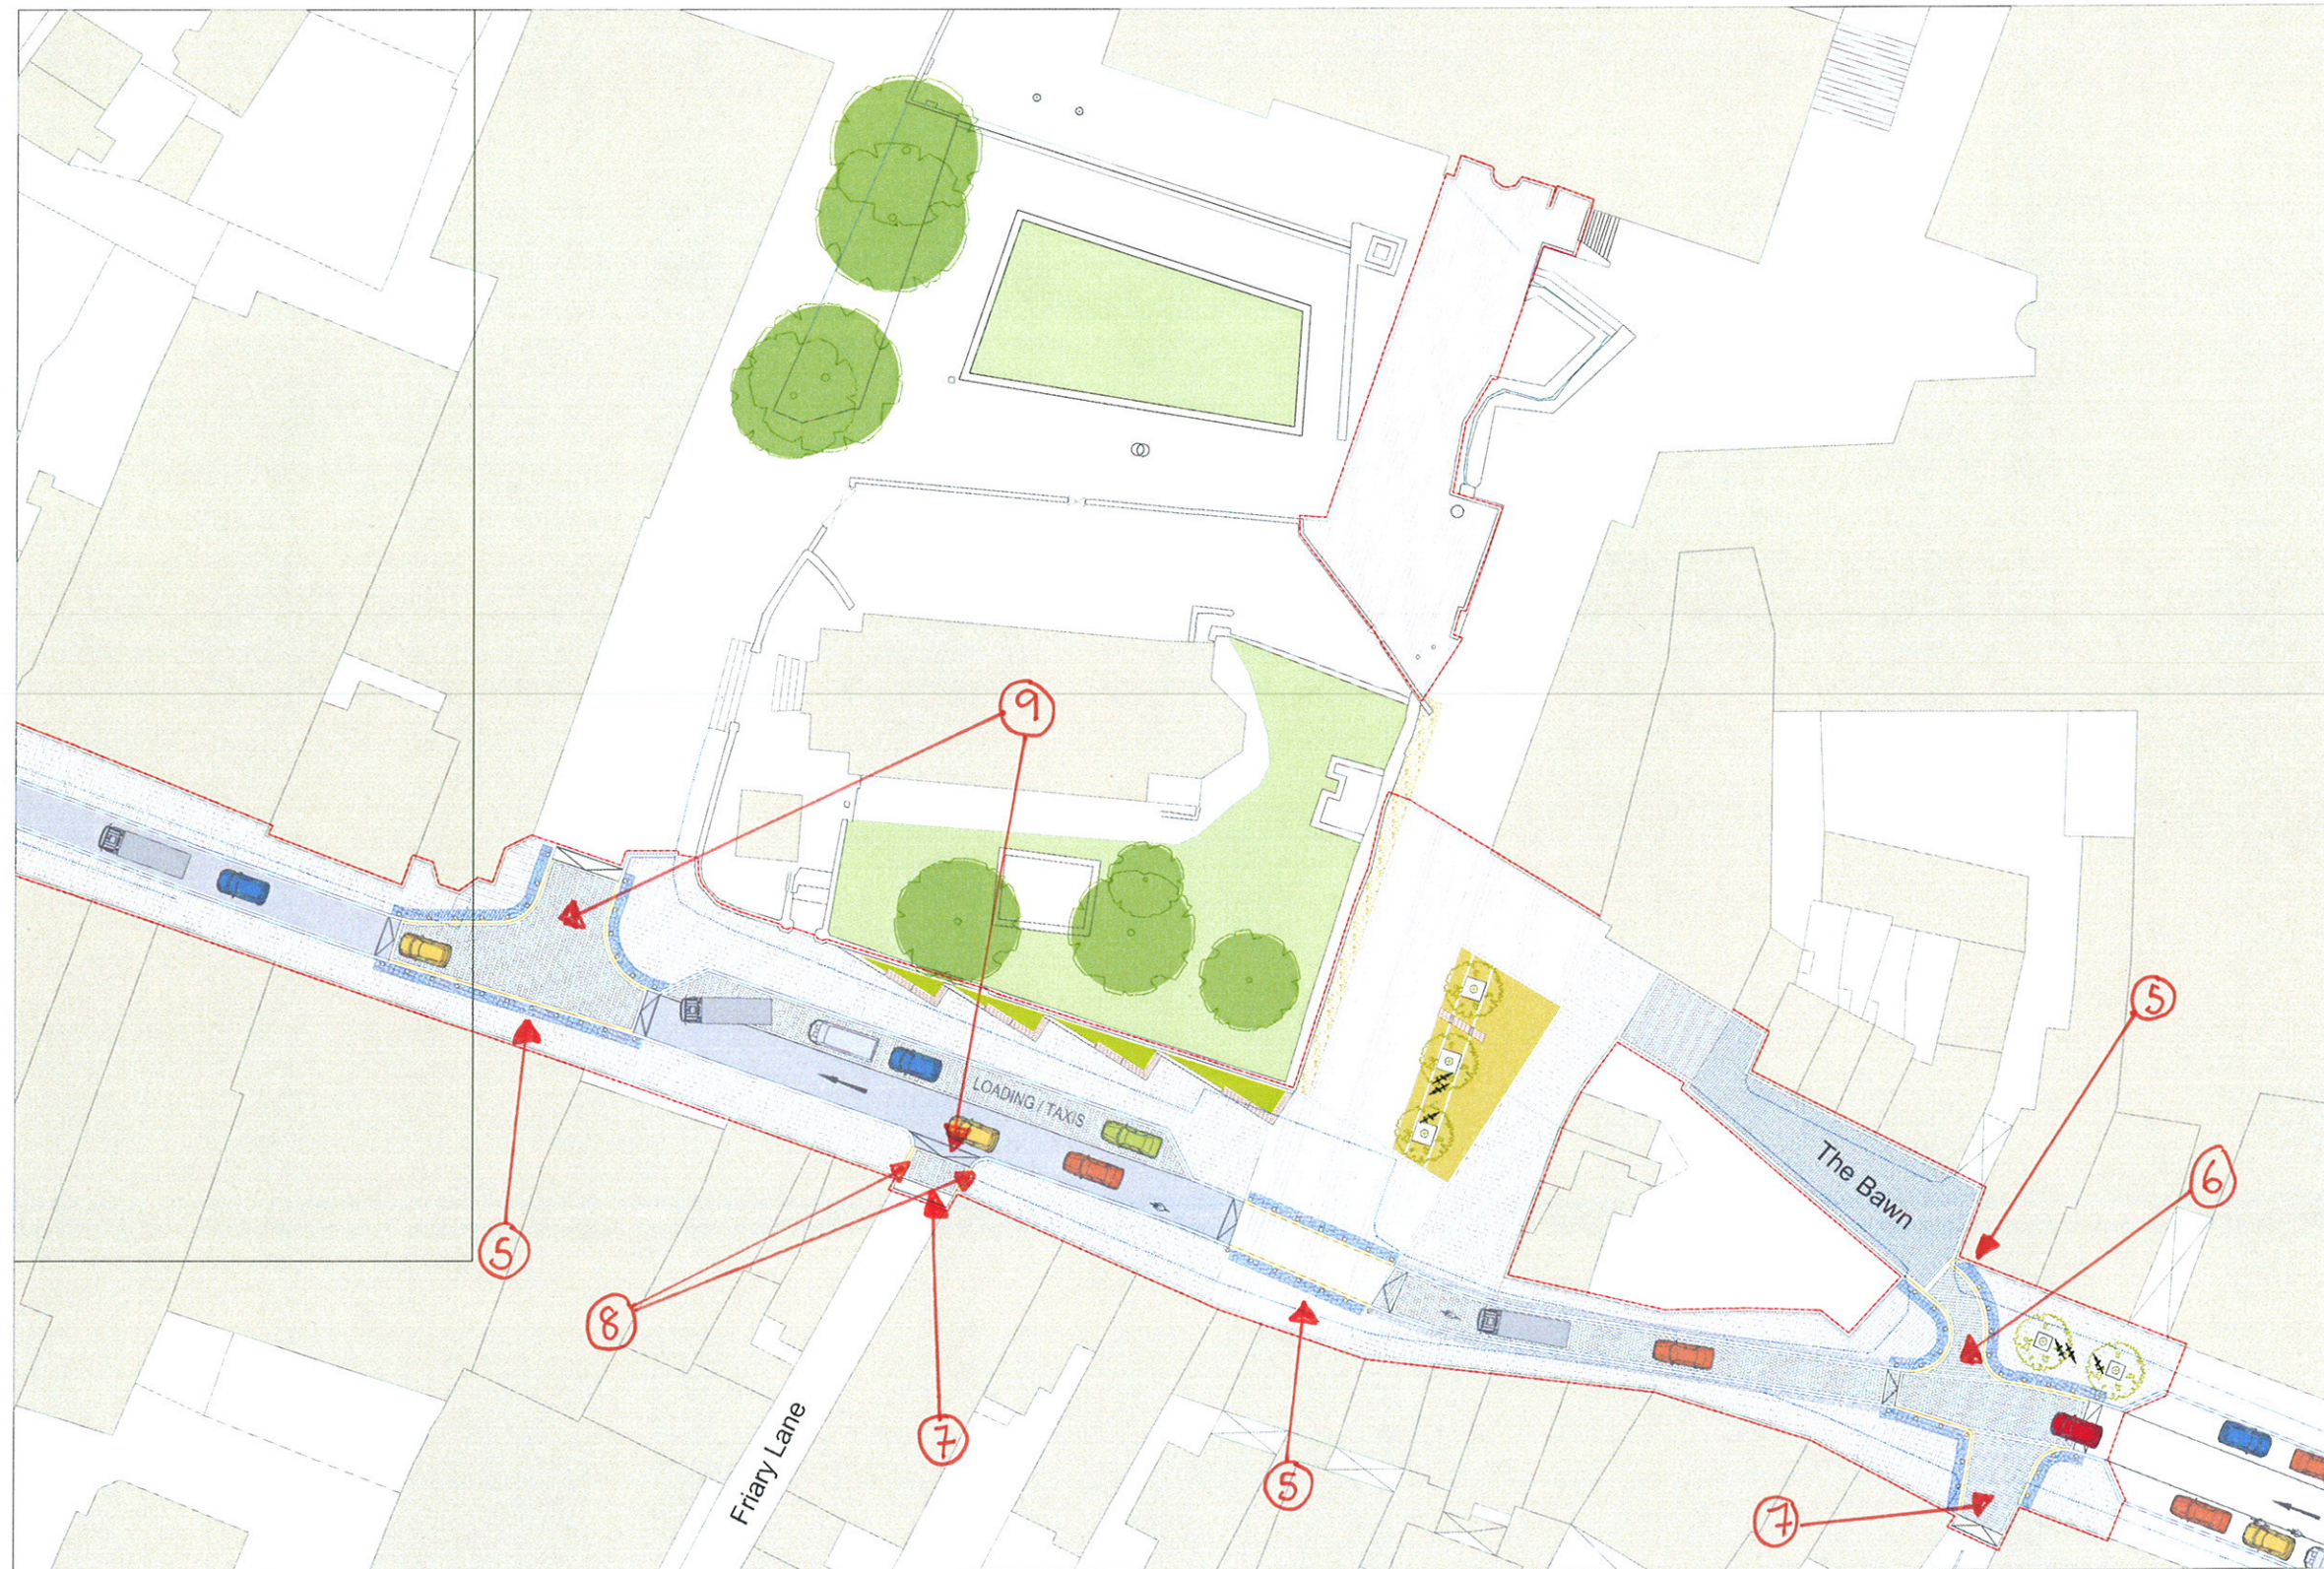
TITLE:  
GENERAL ARRANGEMENT PLAN  
Sheet 1 of 2  
**DRAFT**

Location: 5 – All bollards provided along Church Street.

Summary: Lack of contrasting band, risk to visually impaired pedestrians.

Numerous steel bollards are proposed along Church Street to control vehicle and demark the safe footway areas where raised tables have been provided. It is not clear if the proposed bollards will incorporate a contrasting coloured strip to help identify them to visually impaired pedestrians. If the bollards do not contain a contrasting coloured strip it will be difficult for visually impaired pedestrians to see the bollards and this will increase the risk of them waking into them, or tripping over them, causing the pedestrian an injury.

Location: 6 – The Bawn.

Summary: Narrowing of junction and carriageway with bollards, risk of large vehicles striking bollards.

The existing carriageway and junction area at The Bawn is being reduced in width with the introduction of a raised table and bollards to identify the limits of where vehicles should proceed. The area provided to access The Bawn looks very tight and vehicles may struggle to enter and exit The Bawn without striking the bollards around the junction area.

Location: 7 – Griffith Street and Friary Lane.

Summary: Large level difference creating either a steep area of footway or a drop increasing the risk for pedestrians entering or crossing these side roads.

There is current large level differences at the back of the footway between these side road and Church Street. In some location pedestrian guard rail has been provided to protect pedestrians from these. In the proposed layout dropped kerbs have been shown in these areas, which will either require a very steep section of footway on Church Street, or a steeper section of the side road to bring the exiting road up to the same level. If the gradients are too steep on either the side roads approaching Church Street, or on the Church Street footway this will increase the risk to pedestrians, especially mobility impaired pedestrians, from falling or slipping in icy or wet conditions.

**Location:** 8 – Friary Lane, Lloyd's Lane and Preaching Lane.

**Summary:** No warning tactile paving provided, increased risk of visually impaired pedestrians being struck by a vehicle.

Dropped kerbs have been provided at all of the above junctions along Church Street, but no warning tactile paving has been provided to tell visually impaired pedestrians that they are about to enter the carriageway of the side road. This will increase the risk of a visually impaired pedestrian stepping into the path of a vehicles and being struck when crossing one of these side roads.

**Location:** 9 – Friary Lane, Preaching Lane and Church Street side road past the church.

**Summary:** No signage or road markings to warn drivers of the new one-way system, risk of vehicles turning the wrong way increasing the risk of head on collisions.

The existing road markings and signage on the side roads accessing the new one-way system do not warn drivers that a new one-way system is in operation and that the turning movements at the junctions are restricted. If signage and road markings are not provided this will increase the risk of vehicles turning the wrong way and attempting to travel eastwards along Church Street increasing the risk of a head-on collision.

It is recommended that all proposed bollards have a strip of contrasting colour around them to help visually impaired pedestrians see the bollards.

It is recommended that the swept path of all vehicles that are anticipated to access The Bawn are checked to ensure they can safely enter and leave The Bawn within the new carriageway space provided for them.

It is recommended that the levels on the footways do not exceed a maximum of 1 in 12 over short distances and preferable be no greater than 1 in 20.

It is recommended that blister tactile paving is provided at all side road crossing locations to warn visually impaired pedestrians of the presence of a side road.

It is recommended that signage is provided on the side road and any conflicting road markings or signage is removed to warn driver of the restricted movements at the junction and that they can now only travel in a west bound direction along Church Street.
